MEMORANDUM

Town of Scottsville Hyosung Tire Plant - Pump Station Investigation

Background and Understanding

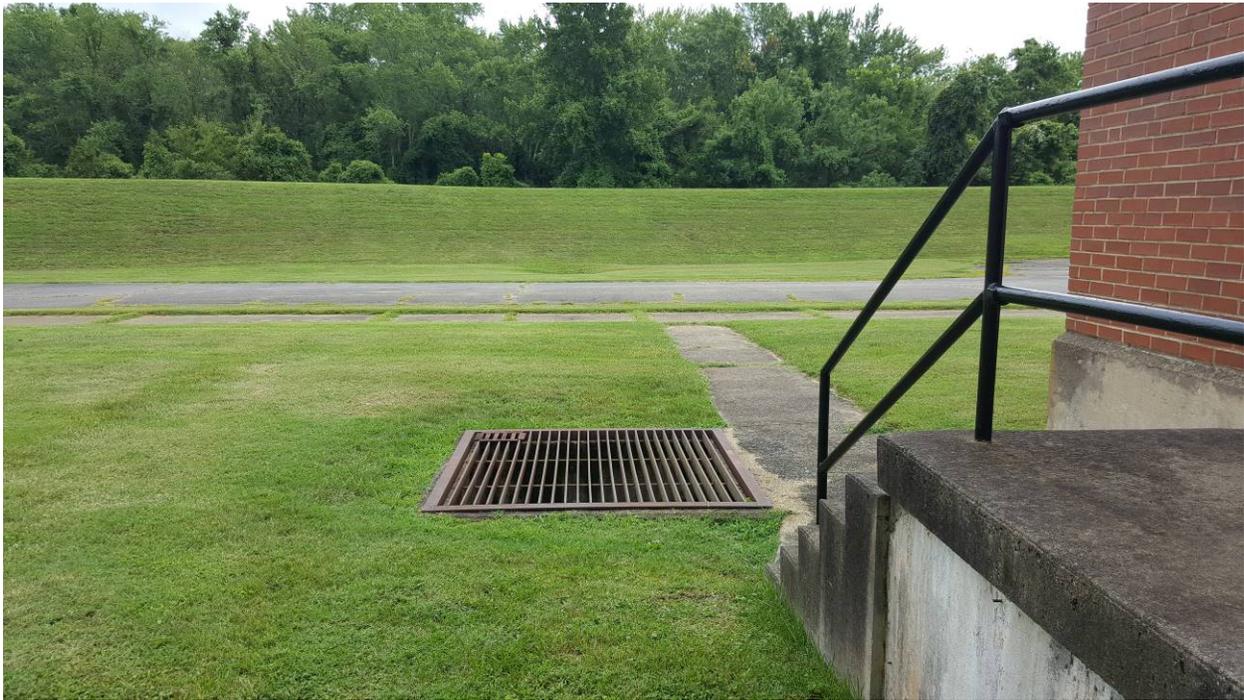
Under normal conditions, a runoff producing rain event falls over the site and flows overland to several drainage inlets throughout the property (refer to Image 1). There are four separate pipe networks (refer to Image 2), ranging in diameter from 12" to 36", that carry flow from the drainage inlets to separate outfalls beyond the berm. Each outfall is equipped with what appears to be a sluice gate type valve (refer to Image 3). The valves are normally open but could be closed when needed with a manual handwheel at the top of a staircase. Once the valves are closed, pumps would need to discharge stormwater from the site.

Image 1. View of drainage inlet from southeastern face of building with berm in the background.

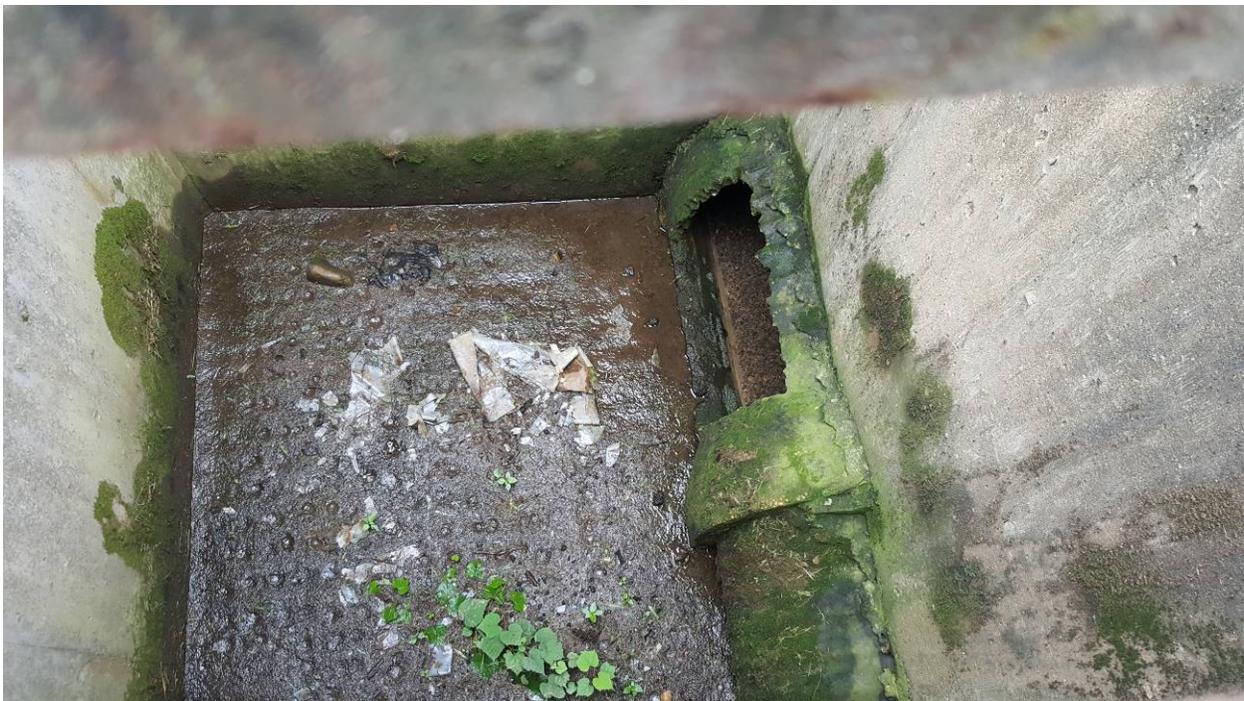
Image 2. Drainpipe within drainage inlet structure.

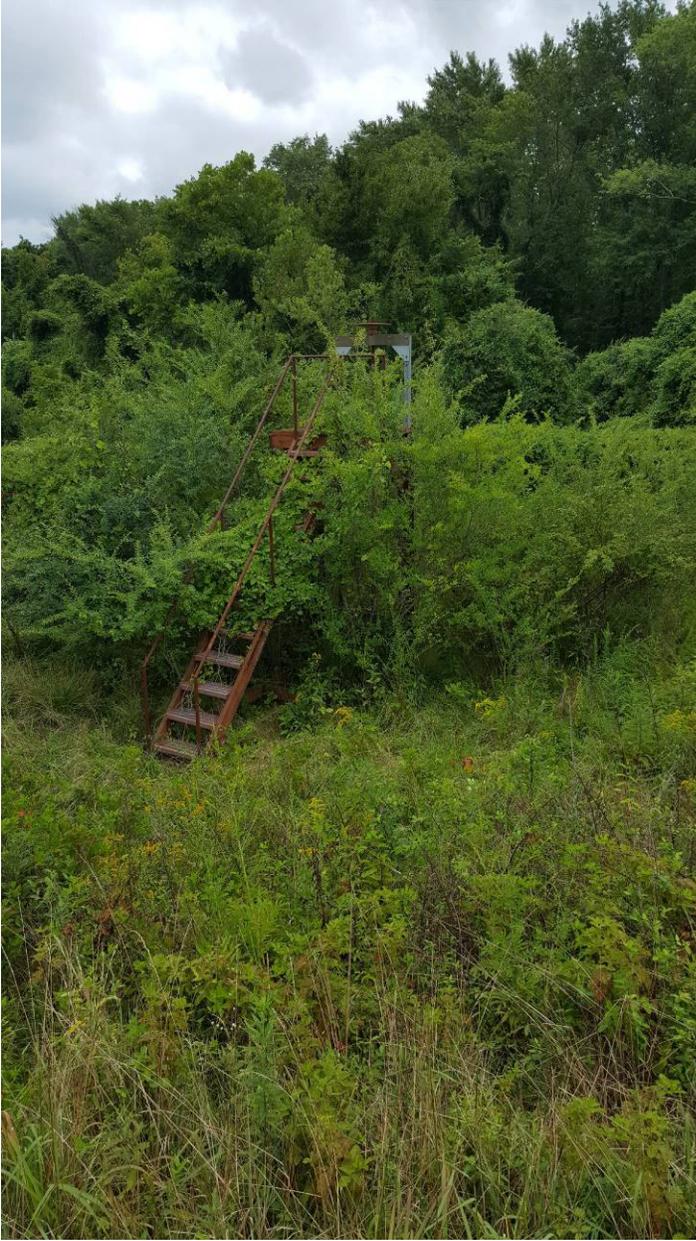
Image 3. Sluice gate valve at northern-most outfall.

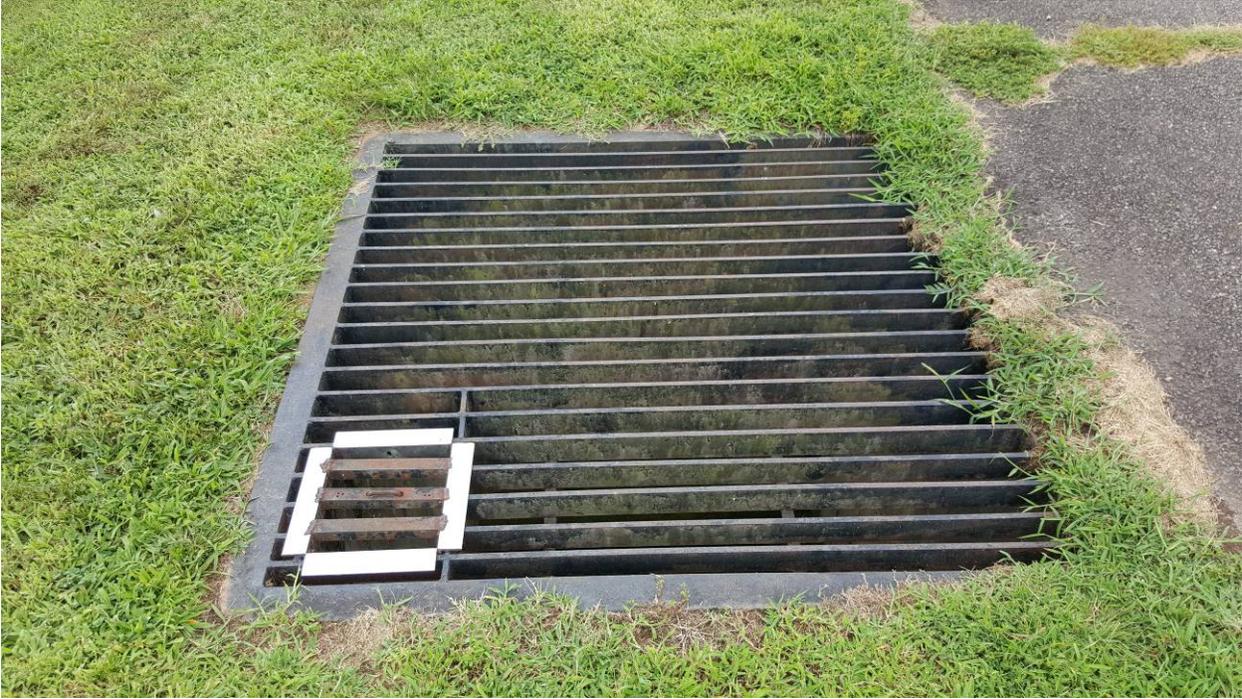
During a flood event, the water surface elevation of the James River could rise above the outfall pipe, preventing runoff from leaving the site or allowing the river to flow into the site. It is understood that the plan was to close the sluice gates and deploy four portable pumps, one for each pipe network. The drainage inlets were outfitted with a small access hatch to allow for the portable pump suction line (refer to Image 4). The pump discharge line, most likely a flexible hose, would be laid on the ground across the property and over the berm.

Image 4. Drainage inlet with access hatch for portable pump suction line.
