# HISTORIC DISTRICT GUIDELINES FOR THE TOWN OF SCOTTSVILLE

## REHABILITATIONS 2

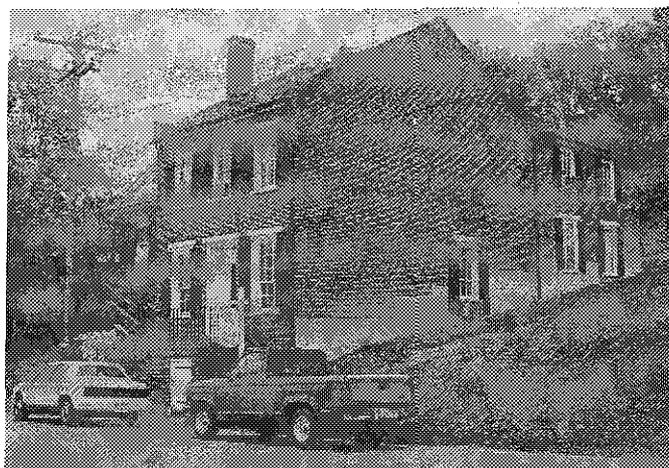
Some notable masonry examples in Scottsville are 300 E. Main Street’s brick cornice, parapet, and projecting cornice ends, all on a Flemish-bond façade; the projecting brick belt course and cornice, pilasters, and decorative diamond-patterned tile designs on 435/475 Valley Street; the massive brick arch, and angled brick soldier course decoration with terra-cotta “rope” trim on 401 Valley Street;

and the simple, yet very vernacular, chimney at 380 East Main Street with its stepped brick weatherings, and projecting drip edge.

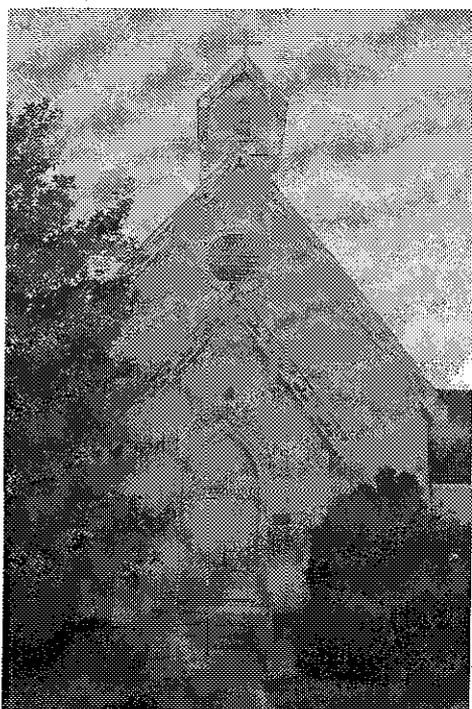
Examples of notable exterior woodwork in Scottsville include the decorative gable-end “tracery” and belfry at the Episcopal Church at 410 Harrison Street, and the almost whimsical “tinker-toy” spindlework on the porch of 210 Jackson Street.

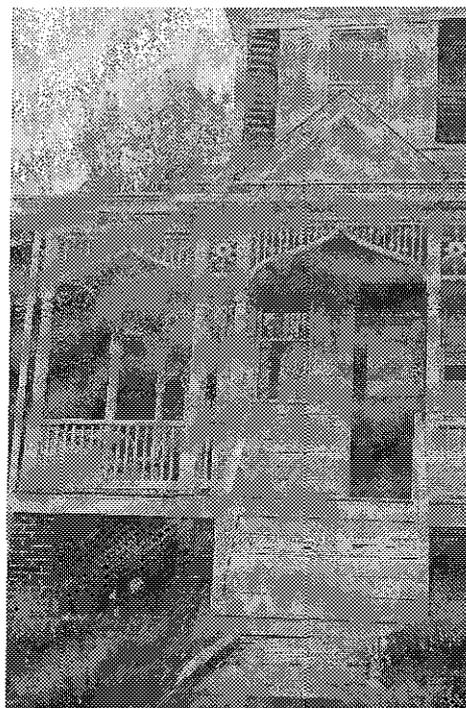
- a. Identifying, retaining, and preserving wood features that are important in defining the overall historic character of the building such as siding, cornices, brackets, window archi-

traves, and doorway pediments; and their paints, finishes, and colors.

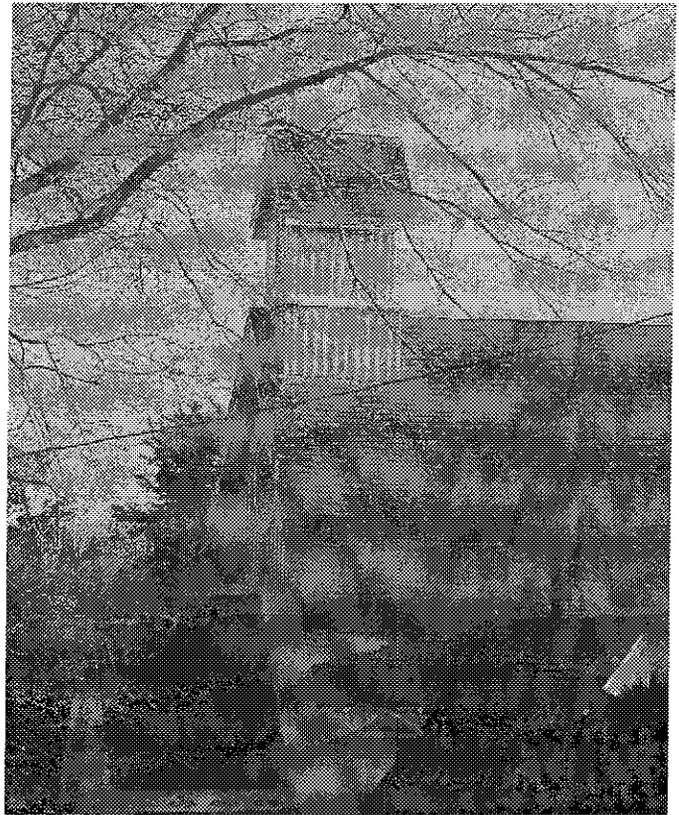
the Old Canal Warehouse at 215/225 South Street; 370/380 Valley Street's slate roof with slate sided dormers; 210 Jackson Street's slate roof with its

signature tower, and the artistic diagonal slate patterns near the peak of the main roof; and 240 Jackson Street's criss-cross intersecting gables.

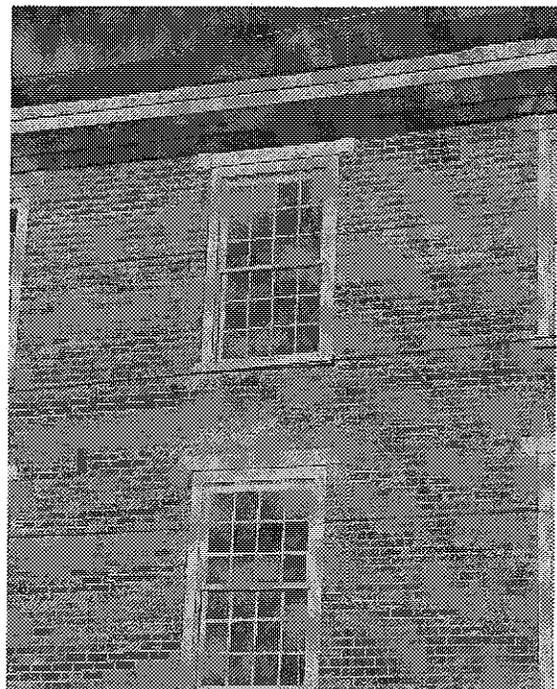
Exemplary window examples in Scottsville include the 12-over-12 Federal-style window sash in the upper floors of 525-561 Valley Street; 145 Bird

Street's decorative window surrounds that include moulded window trim, rondel blocks at the upper corners, and a long wood lintel over the entire opening; and the stylish tripartite windows of 354 Harrison Street.

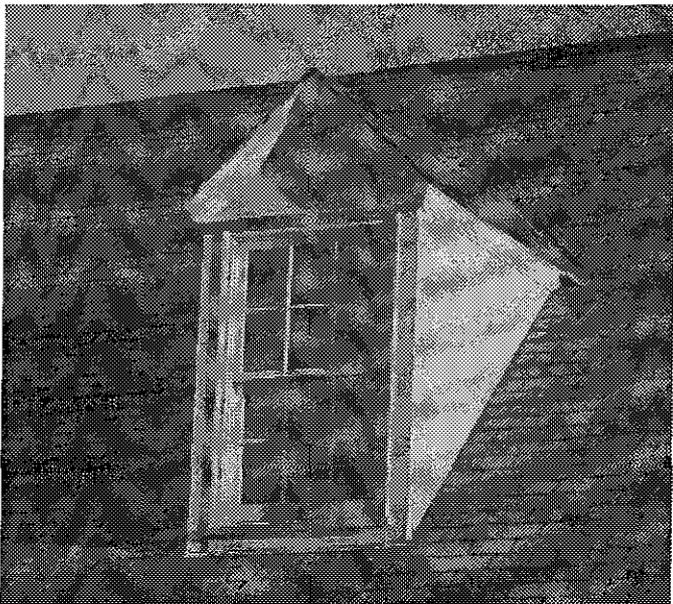
- a. Identifying, retaining, and preserving windows – and their functional and decorative features – that are important in defining the overall historic character of the building. Such features can include frames, sash, muntins, glazing, sills, heads, hoodmolds, paneled or decorated jambs and moldings, and exterior shutters and blinds.

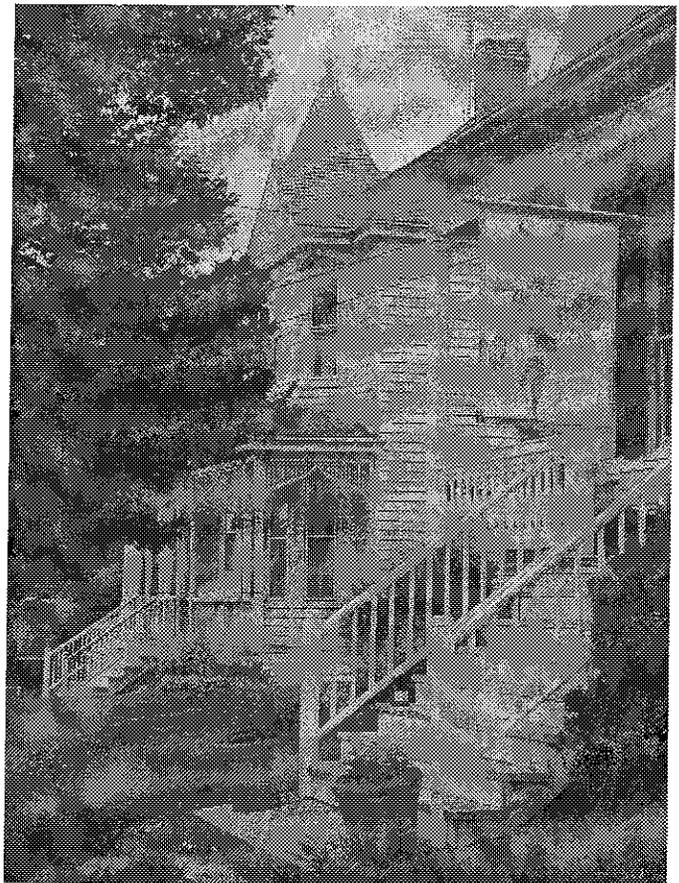
An excellent example of an original un-altered porch is on the Queen Anne style house at 210 Jackson Street with its curved braces, delicately turned spindles and columns. Other character-defining porches in Scottsville are found at the "Old Tavern" at 360 Main Street with its diamond shaped grille railings and square tapered columns; and 550 Valley Street's
